DOE/NV--1151

Post-Closure Inspection and
Monitoring Report for Corrective
Action Unit 342: Area 23 Mercury
Fire Training Pit, Nevada Test Site,
Nevada

For Calendar Years 2004-2005

August 2006

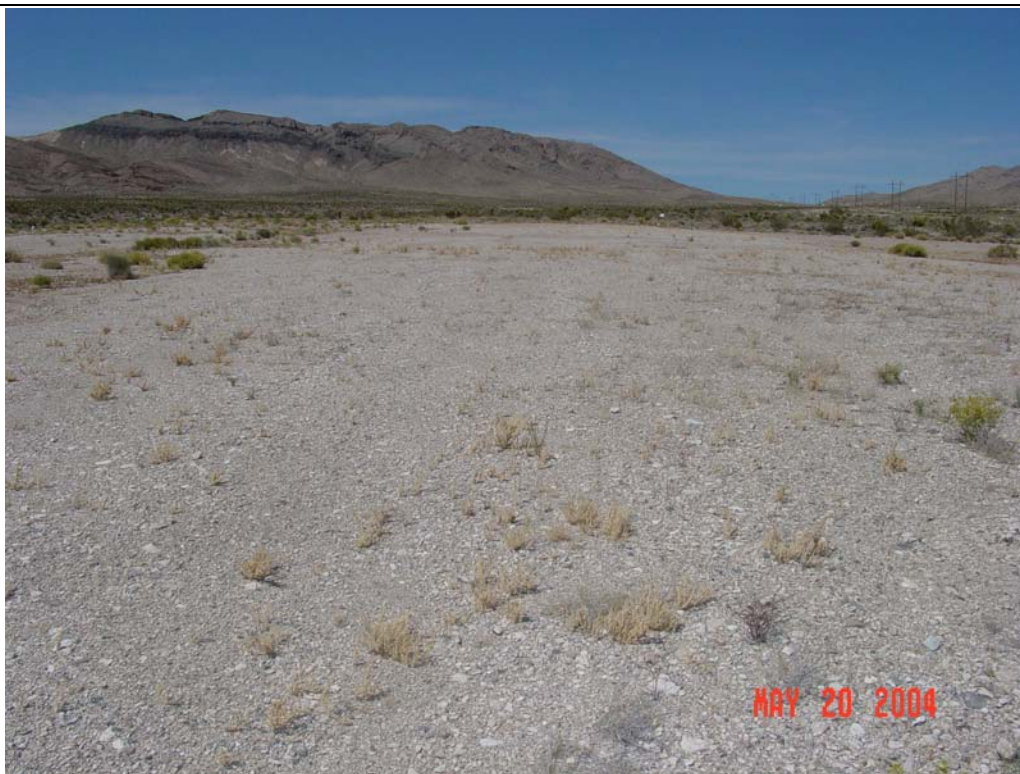
Photograph 1: CAU 342, Former Aboveground Storage Tank Area, Facing North, 05/20/2004

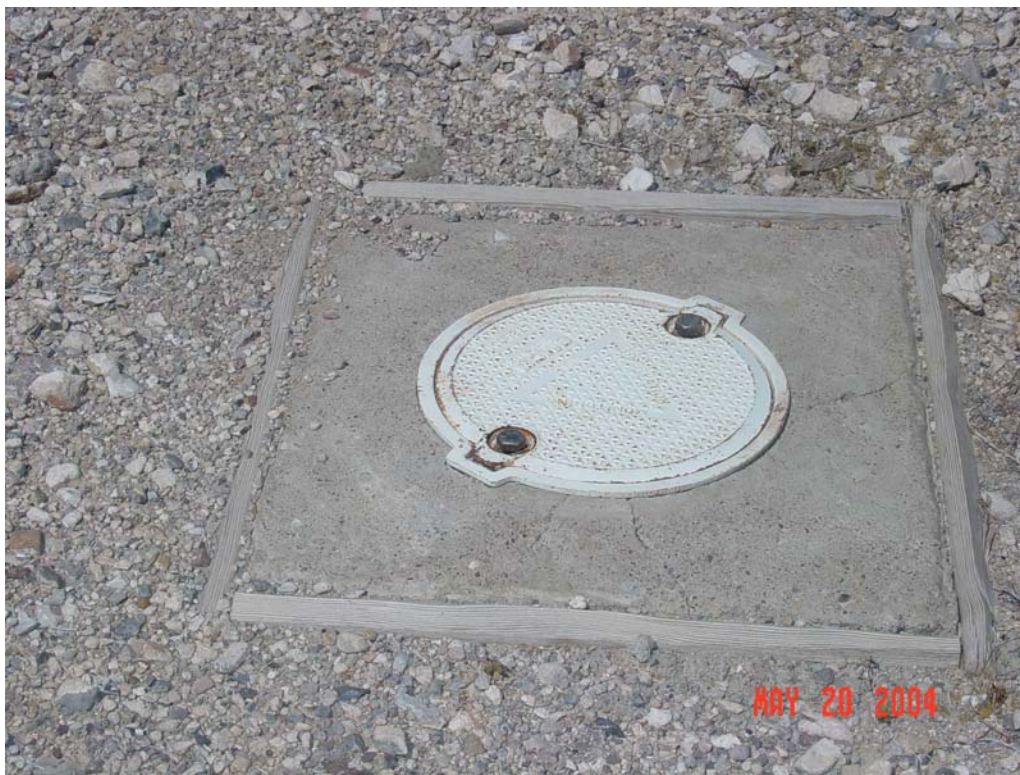
5. Condition of monitoring well and cover (cracked, tilted): Good condition
6. Condition of fencing (breaks, tilted, damaged): Fence is in excellent condition
7. Condition of signs (missing signs, fading, damaged): Signs are in good condition
8. Signs of erosion indicating runoff or runoff (into) the area that could impact the monitoring well?
No ☒ Yes ☐ If yes, explain: _____

Photograph 2: CAU 342, Soil Gas Monitoring Well, 05/20/2004

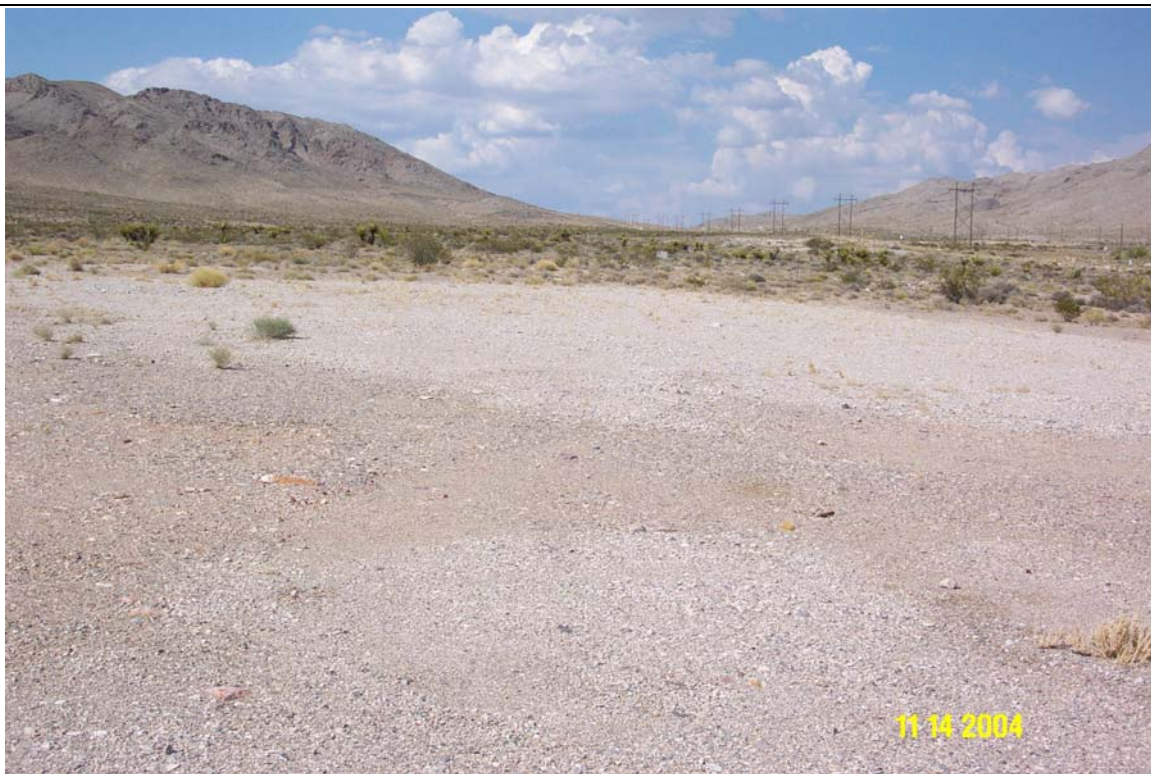
Photograph 3: CAU 342, Former Aboveground Storage Tank Area, Facing North, 11/14/2004

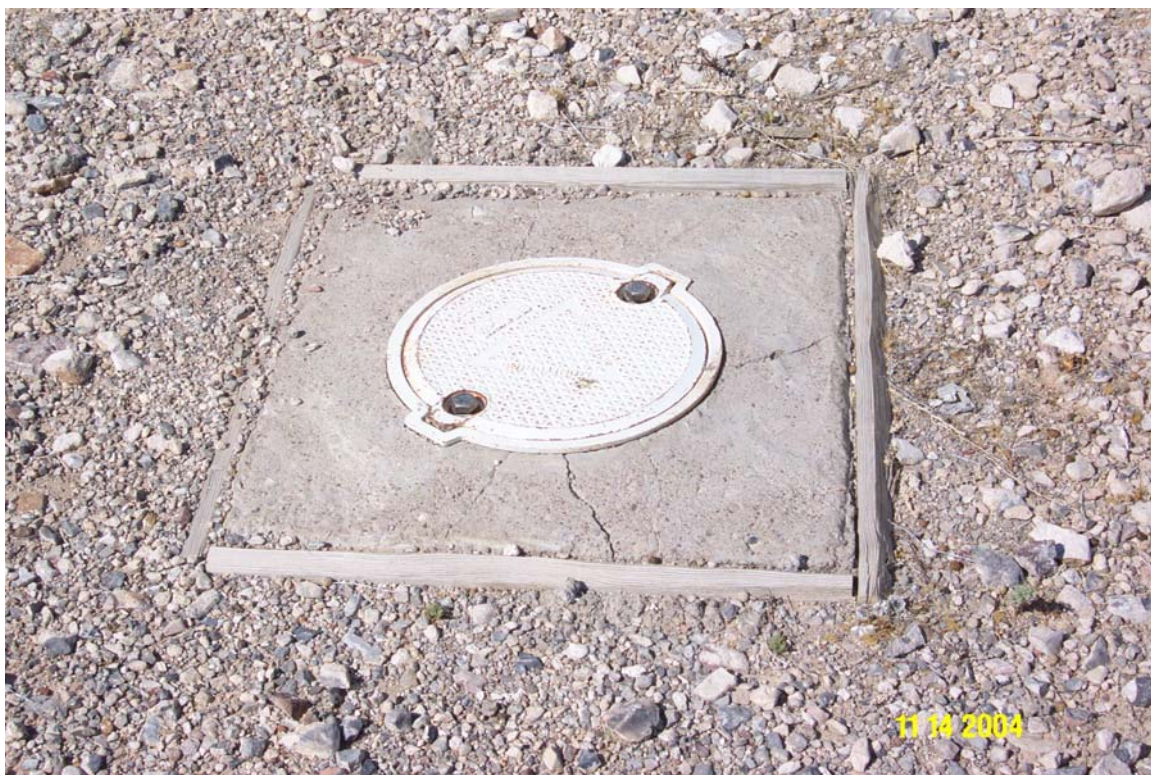
5. Condition of monitoring well and cover (cracked, tilted): Good condition slight crack in concrete cover, lid/well plug securely sealed well
6. Condition of fencing (breaks, tilted, damaged): Excellent - no breaks or downed areas
7. Condition of signs (missing signs, fading, damaged): All use restriction warning signs present and legible
8. Signs of erosion indicating runoff or runoff (into) the area that could impact the monitoring well?
No ☒ Yes ☐ If yes, explain: _____

Photograph 4: CAU 342, Soil Gas Monitoring Well, 11/14/2004

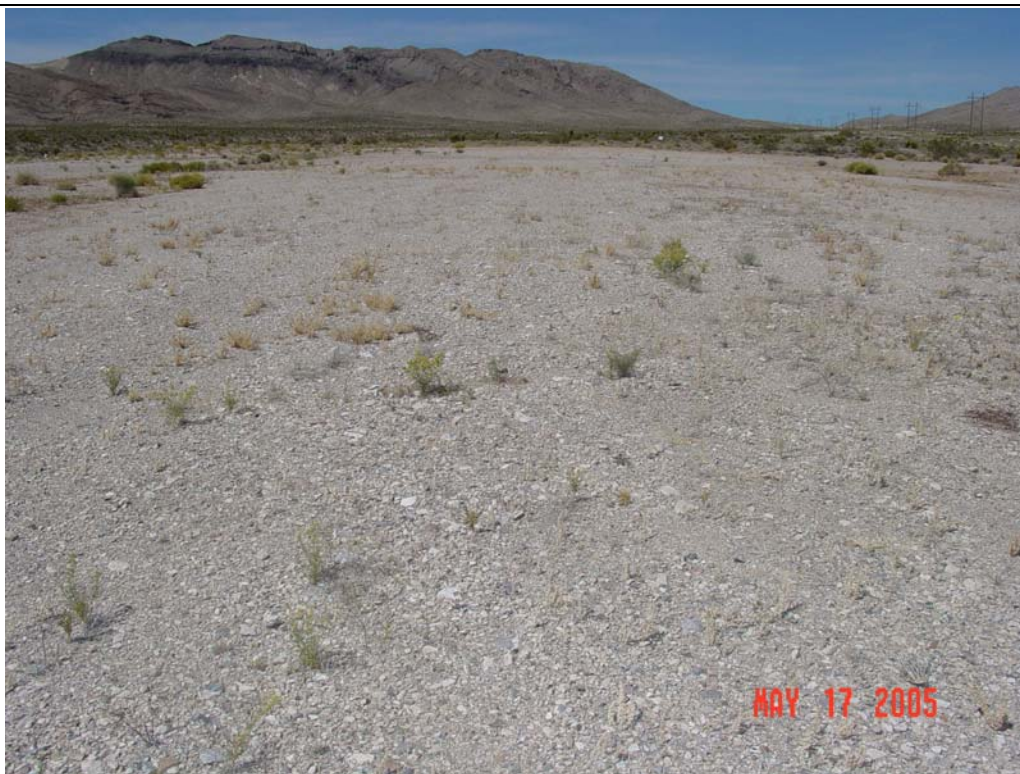
Photograph 5: CAU 342, Former Aboveground Storage Tank Area, Facing North, 05/17/2005

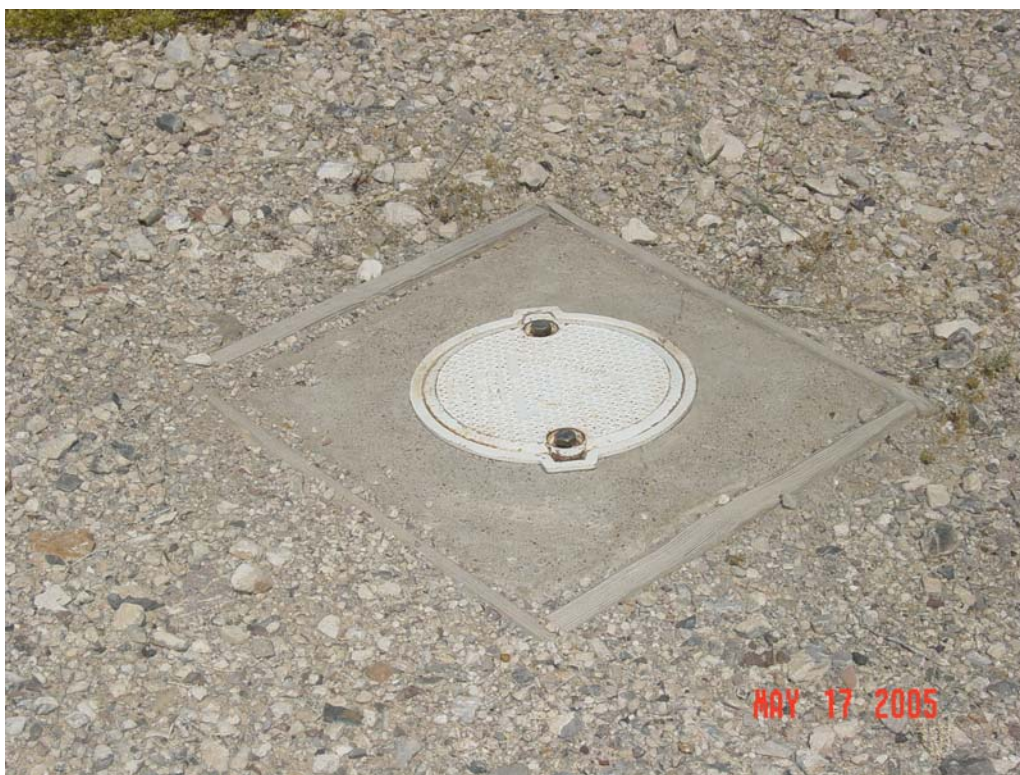
5. Condition of monitoring well and cover (cracked, tilted): Monitoring well & cover in good condition
6. Condition of fencing (breaks, tilted, damaged): Good condition
7. Condition of signs (missing signs, fading, damaged): Good condition
8. Signs of erosion indicating runoff or runoff (into) the area that could impact the monitoring well?
No ☒ Yes ☐ If yes, explain: _____

Photograph 6: CAU 342, Soil Gas Monitoring Well, 05/17/2005

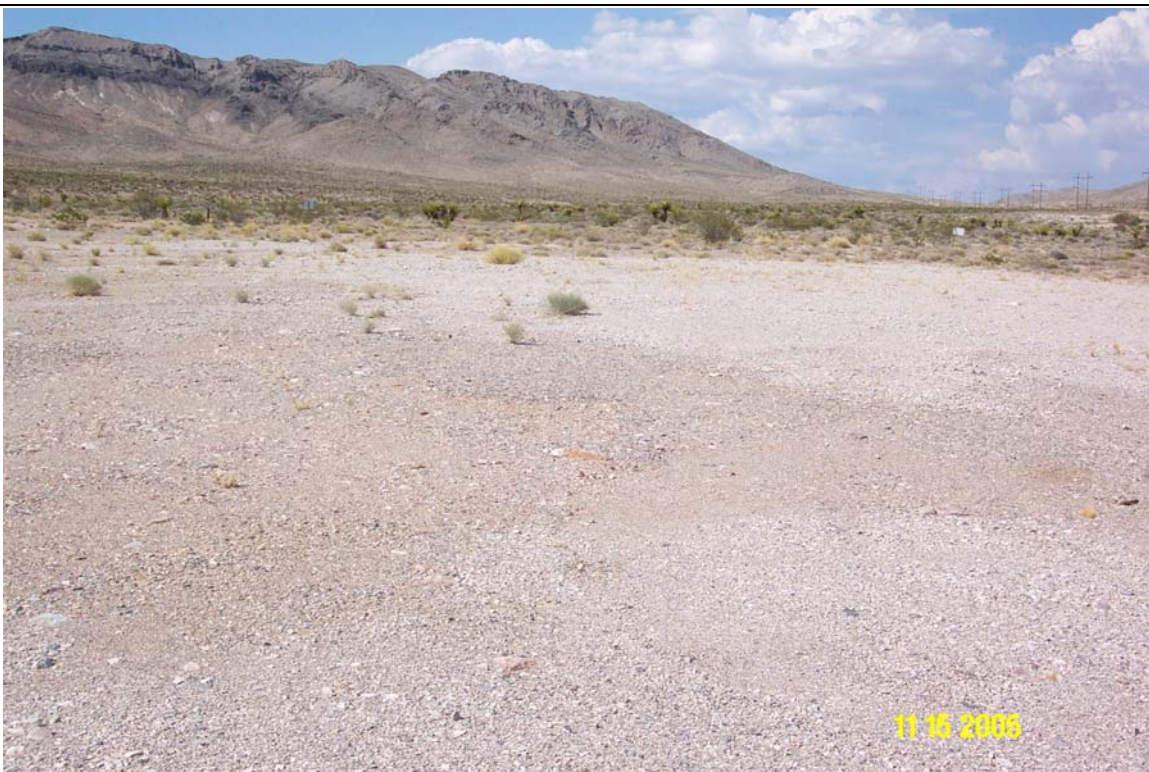
Photograph 7: CAU 342, Former Aboveground Storage Tank Area, Facing North, 11/15/2005

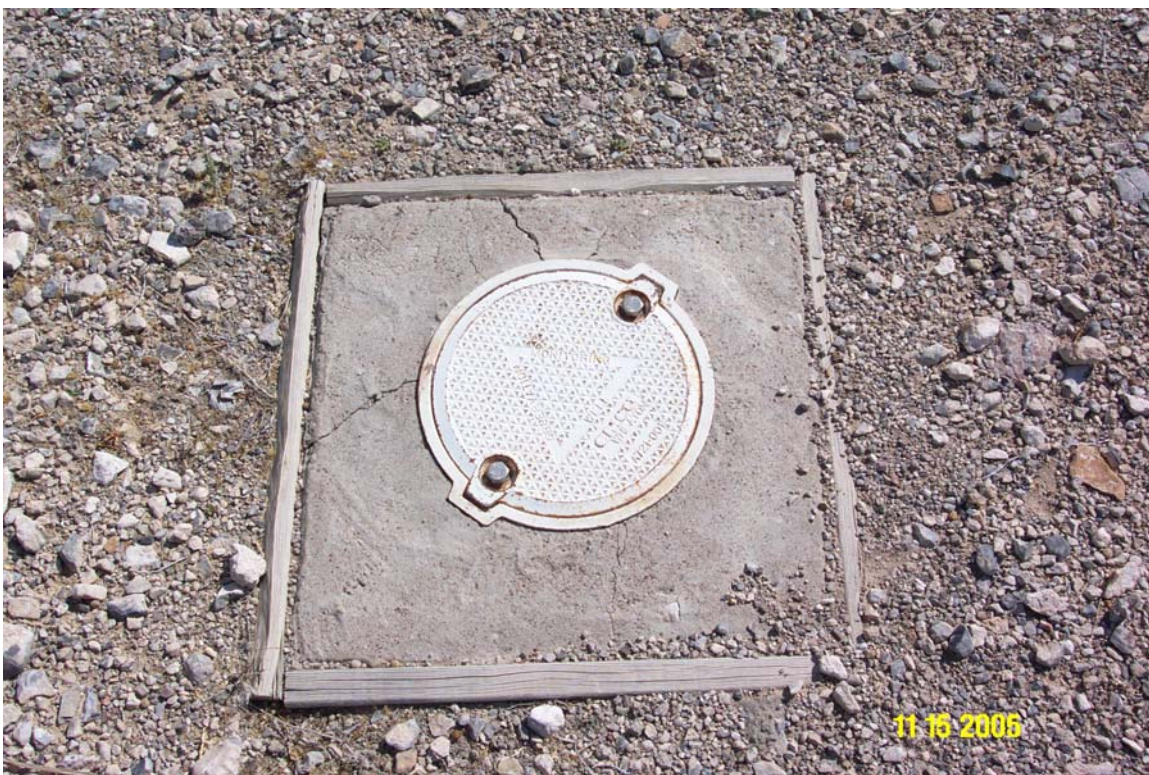
5. Condition of monitoring well and cover (cracked, tilted): good condition, slight crack in concrete cover. Well plug in excellent condition with tight seal
6. Condition of fencing (breaks, tilted, damaged): Excellent condition. No downed areas or breaks
7. Condition of signs (missing signs, fading, damaged): All use restriction signs are present and in excellent condition.
8. Signs of erosion indicating runoff or runoff (into) the area that could impact the monitoring well?
No ☒ Yes ☐ If yes, explain: _____

Photograph 8: CAU 342, Soil Gas Monitoring Well, 11/15/2005
